Memorandum

Date: *August 15, 2014*

Subject: *Oversight Summary Report
CPG Oversight of RM 10.9 Removal Action
Lower Passaic River Restoration Project*

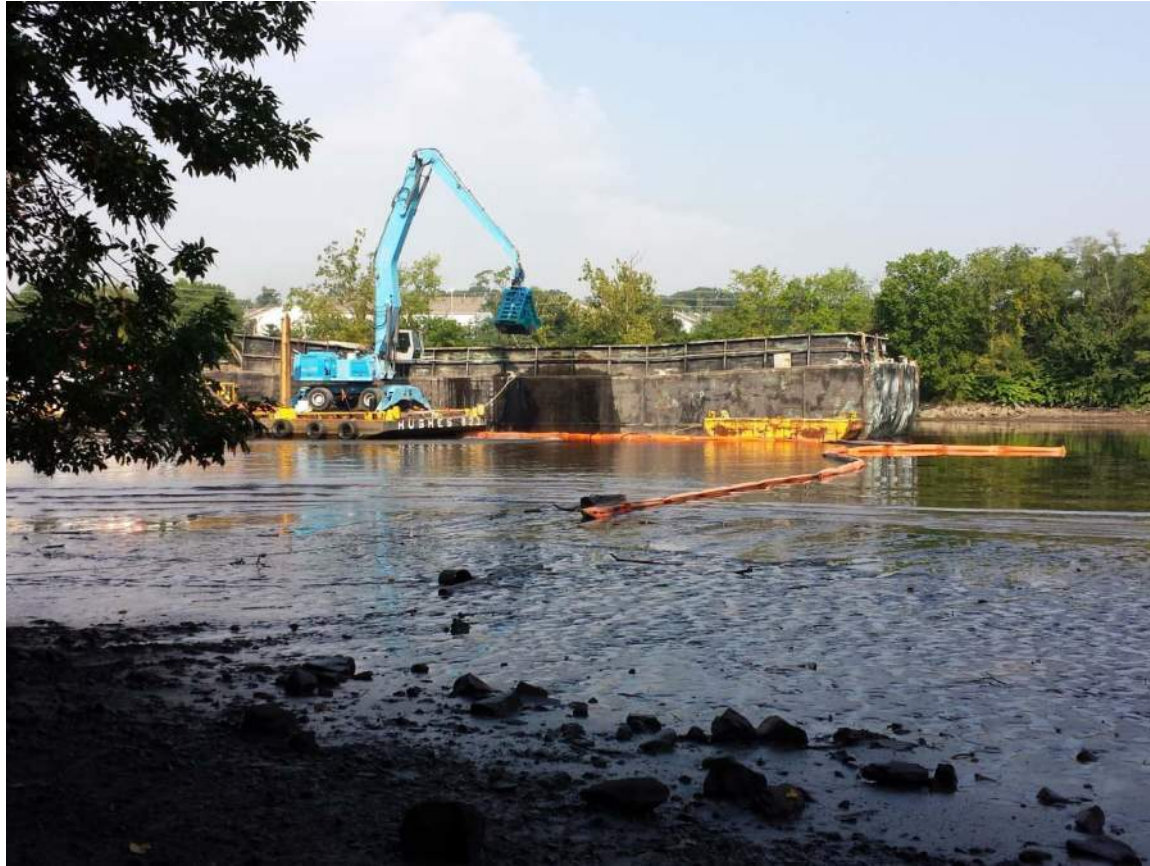
Dredge Activity This Morning

Good Clean seal observed. During low tide.

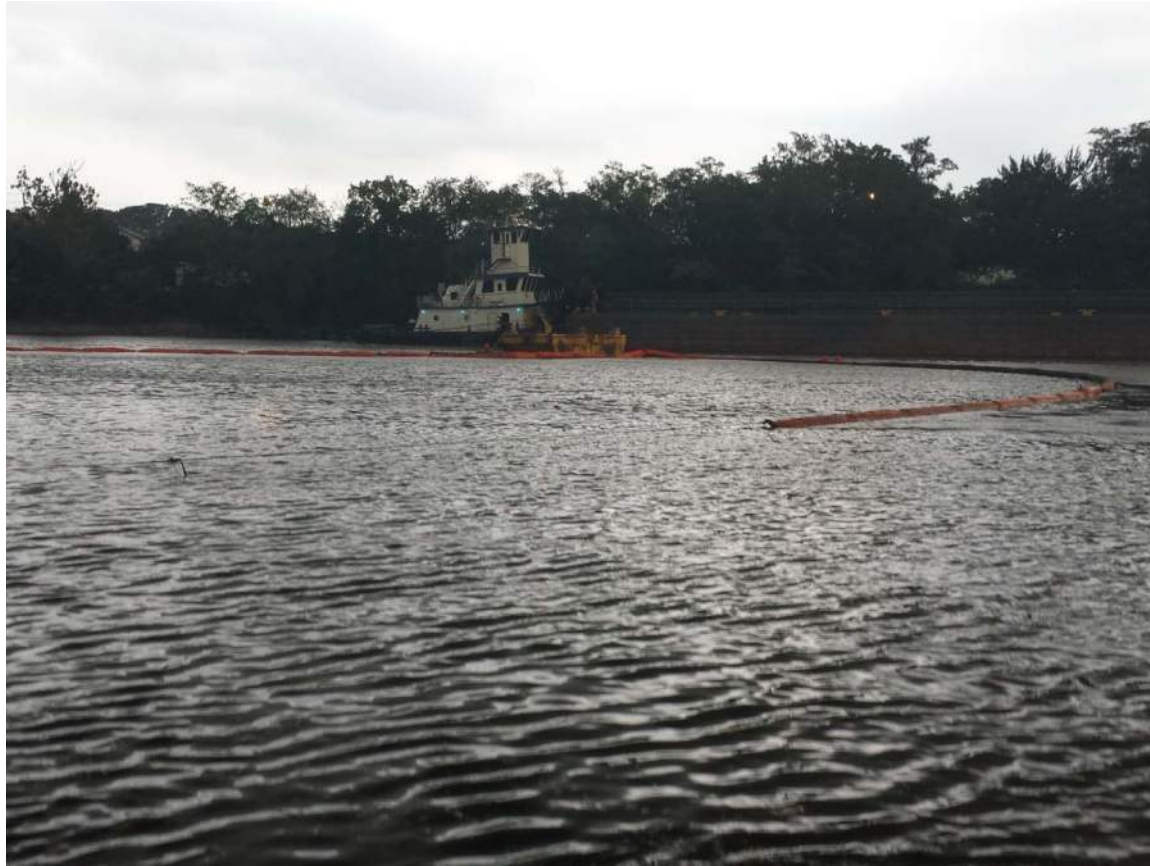
Storm Moving In

Change in surface water conditions due to strong winds.

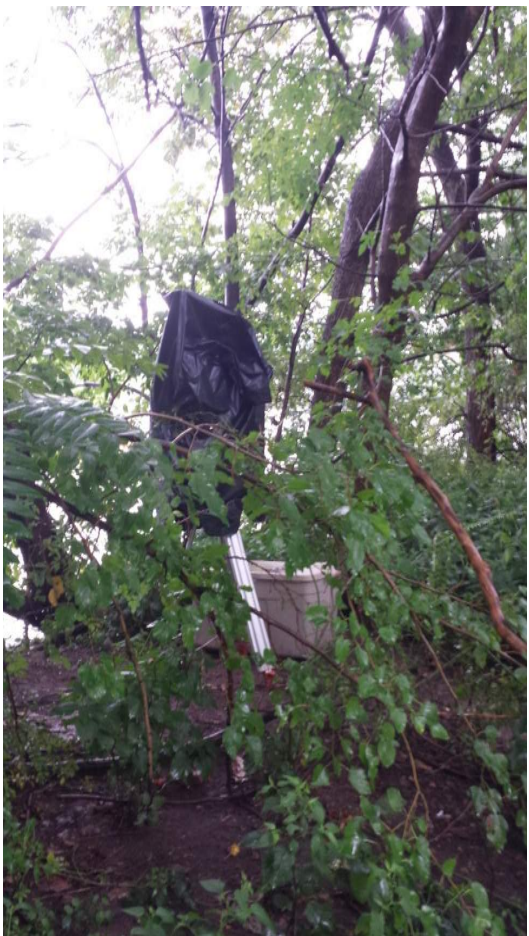
Mobile Air Monitoring Station

Mobile air monitoring station is properly covered during wet weather event so none of the instruments are damaged.

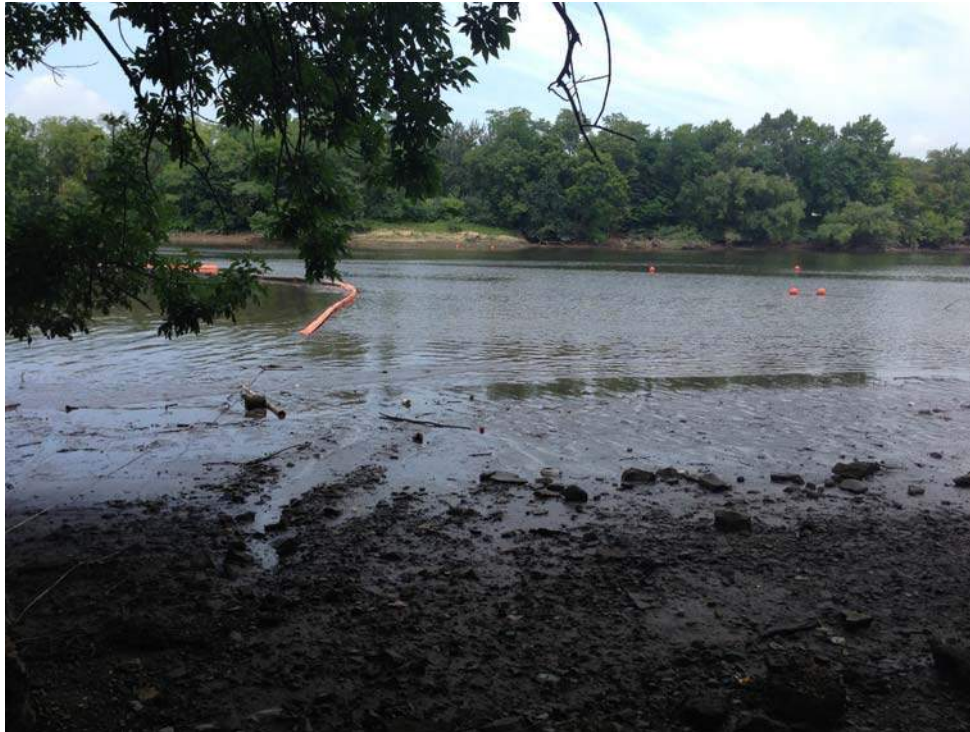
Water Main Offset Buoys

The buoys indicating the 72" water main (and 30' offset) have drifted north due to the tide, and should be located nearer the center of this photograph. De Maximis and CH2M Hill are aware of this and will be closely observing GLDD when they approach this area. The water main location can be easily discerned with the help of markers on the shore line, thus all parties know where they actually are and where to exercise caution.

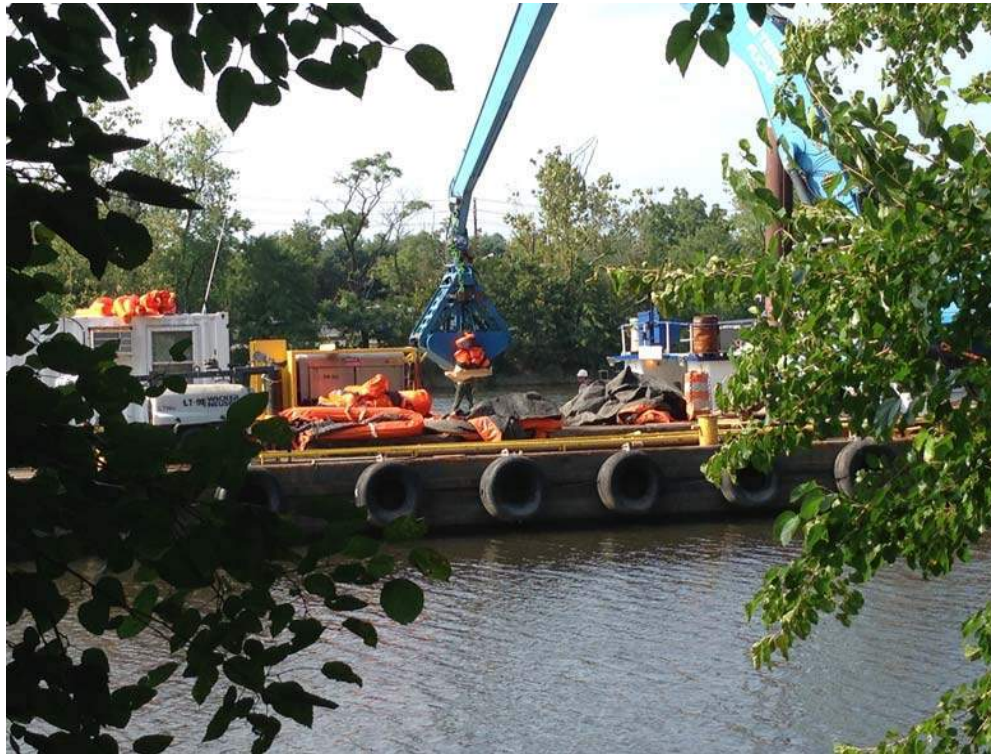
Silt Curtain Unpackaging

At the end of the day, GLDD were observed pulling sections of the silt curtain from the river, meanwhile unpacking new sections on the barge. It is anticipated that these will be installed tomorrow.

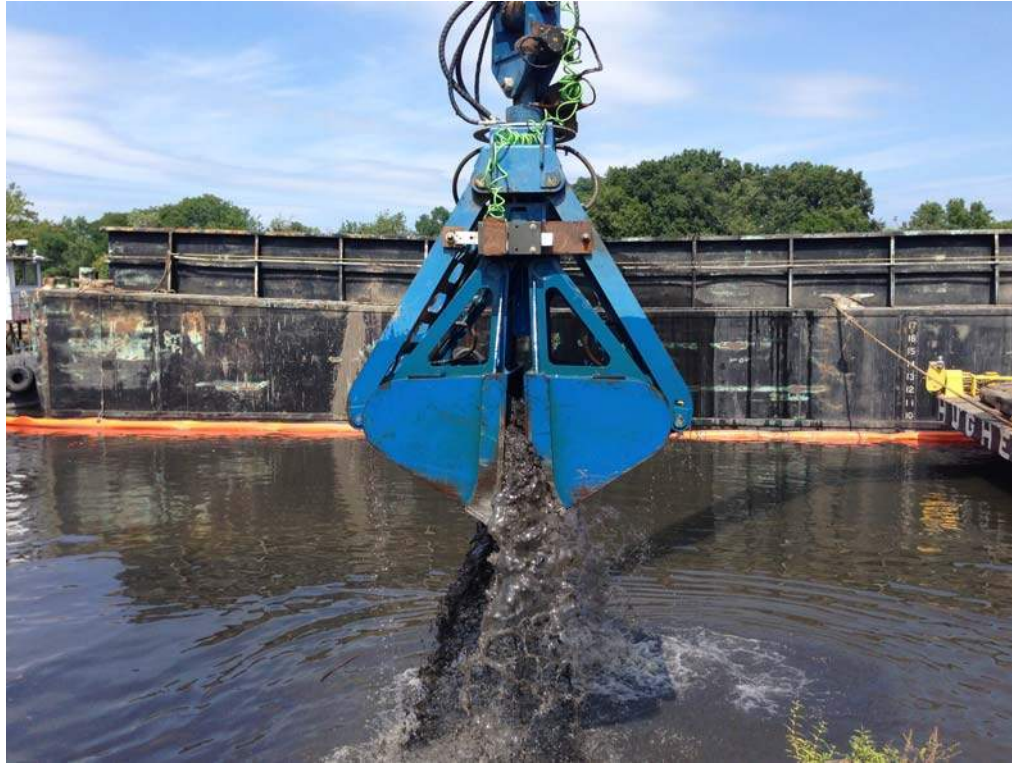
Area 2 Dredging

GLDD dredged in Area 2 today. Noticeable debris prevented a clean seal on many of the passes, as shown above. Dredging progressed without delay.

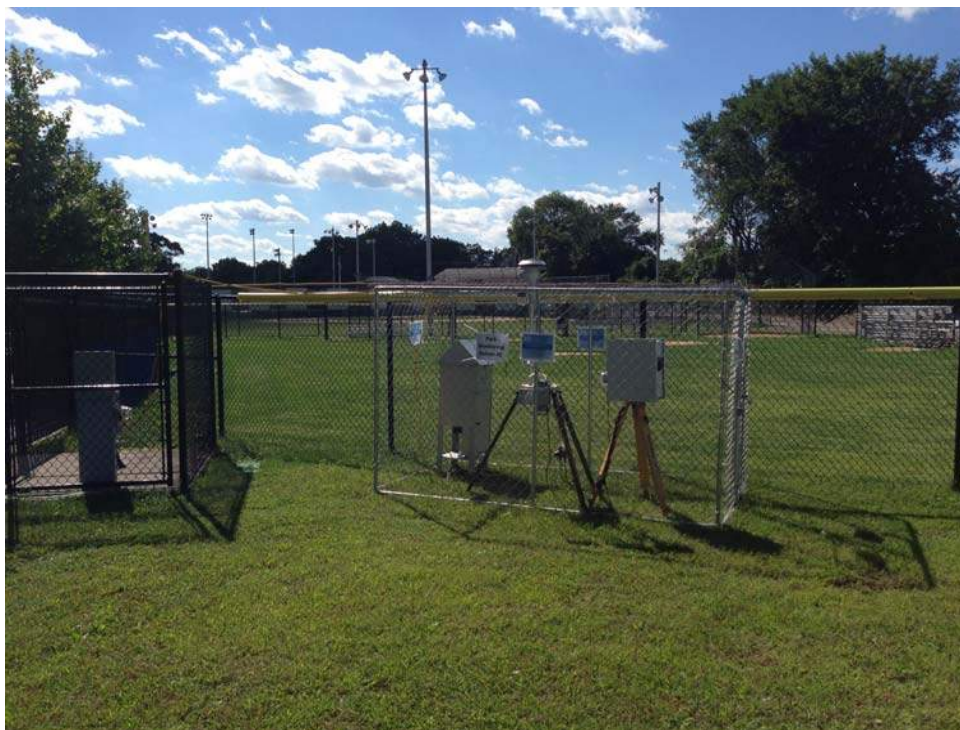
PMS #2 relocation

CH2M Hill relocated PMS #2 from the southern edge of the dredging area to the northern edge, now that dredging has progressed to Area 2. The monitoring station is located just north of the northernmost baseball field and will continue to monitor VOCs, dust and H₂S in real-time and collect COPC samples as required. PMS #3, located near the United Water pump station, is now the southernmost monitoring station.

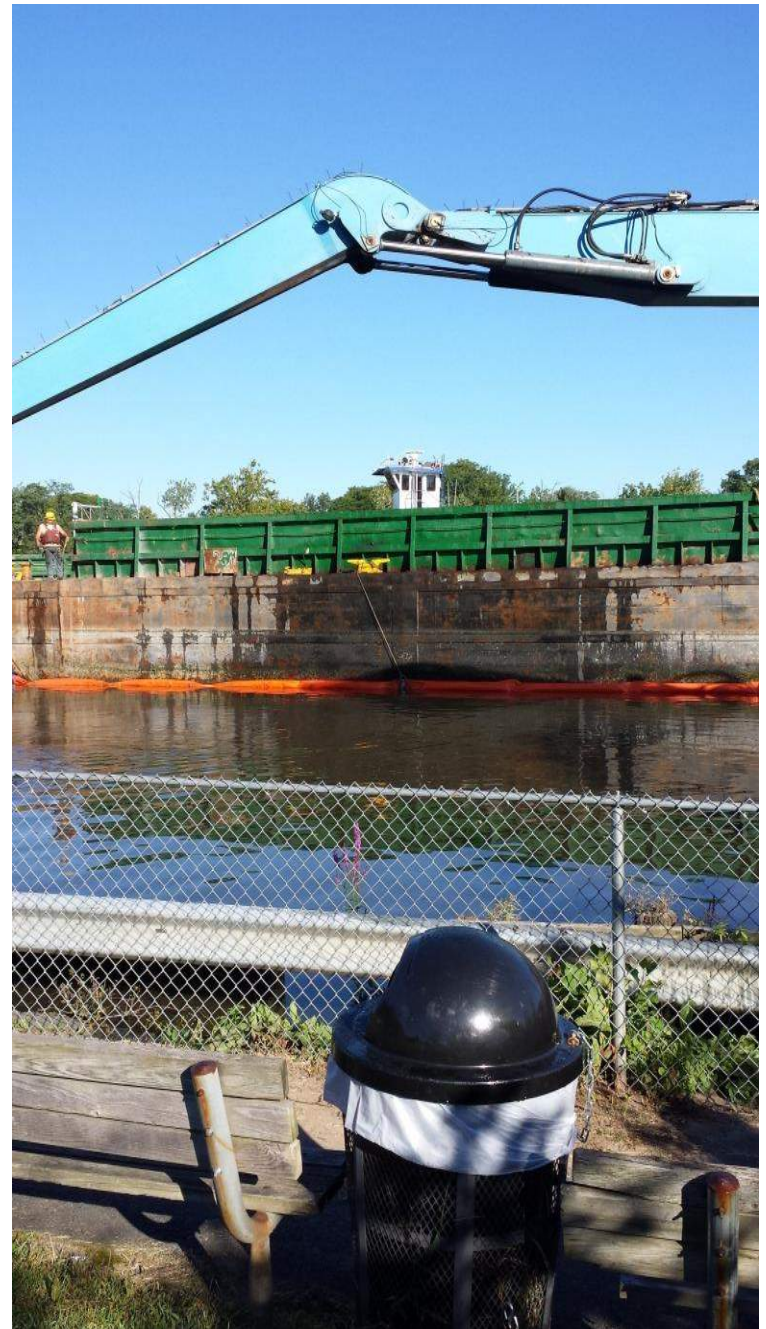
Shoreline Dredging During Low Tide

Since the area next to the boat launch is deeper than the previously dredged areas, the operator was able to reach the shoreline during low tide.

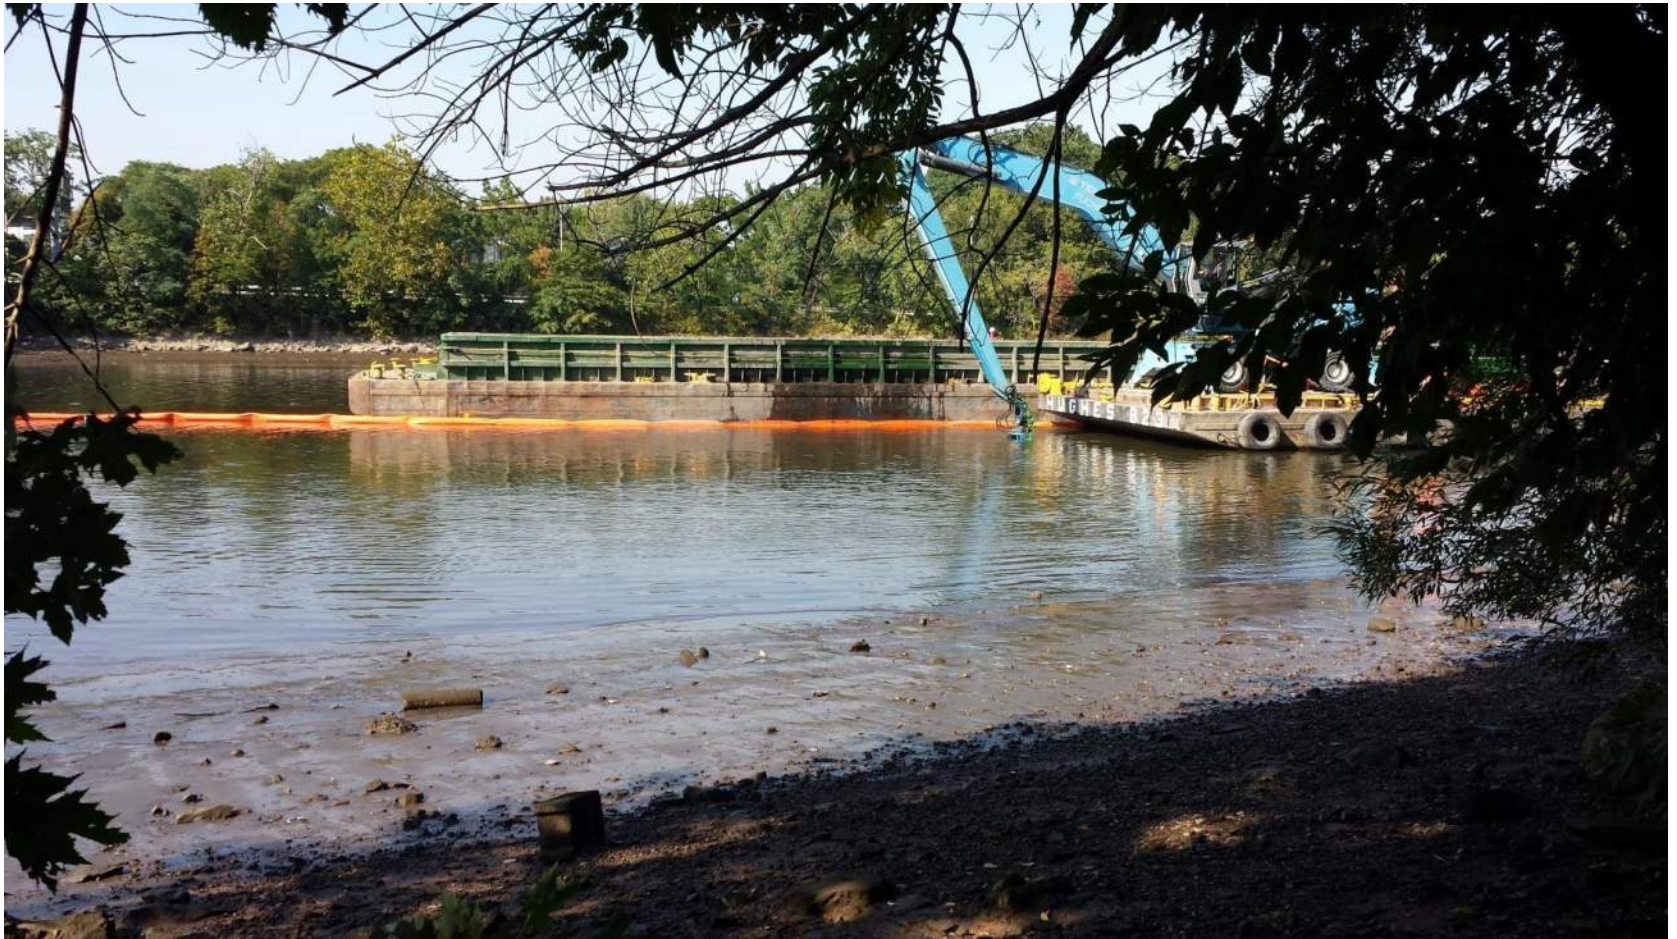
1545 Final “Chubby Draft”

Final Draft of “Chubby” is approximately 8.5 – 9 ft. Scale on side of scow was obscured.

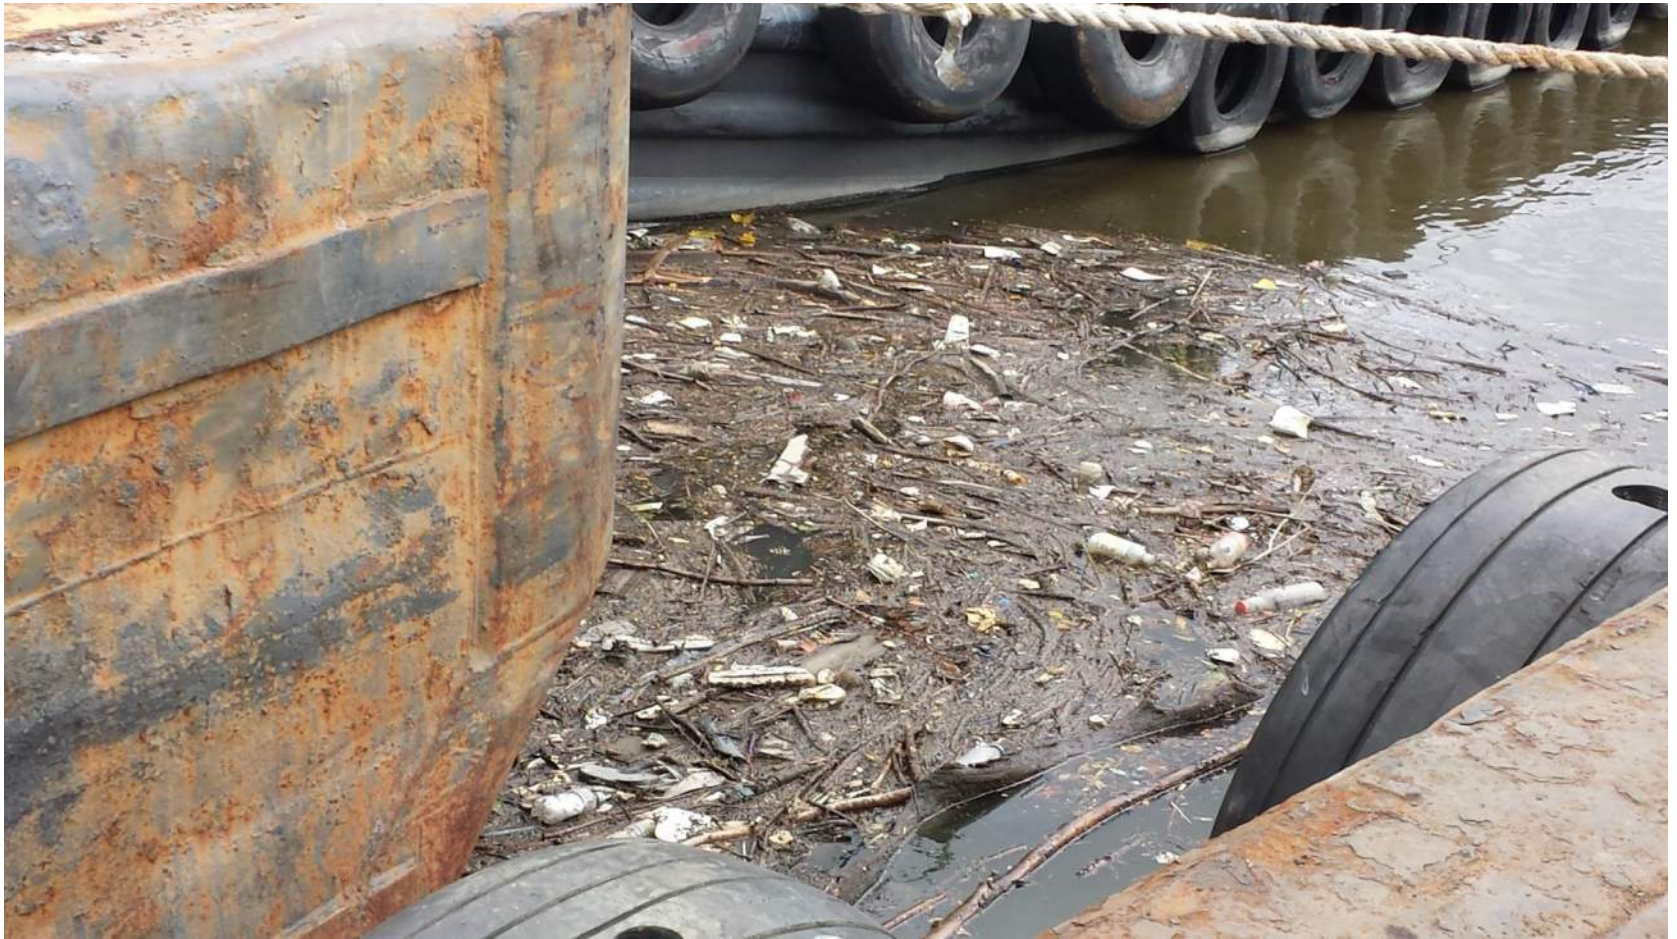
Trash/Debris build up around Scow and Dredge Barge

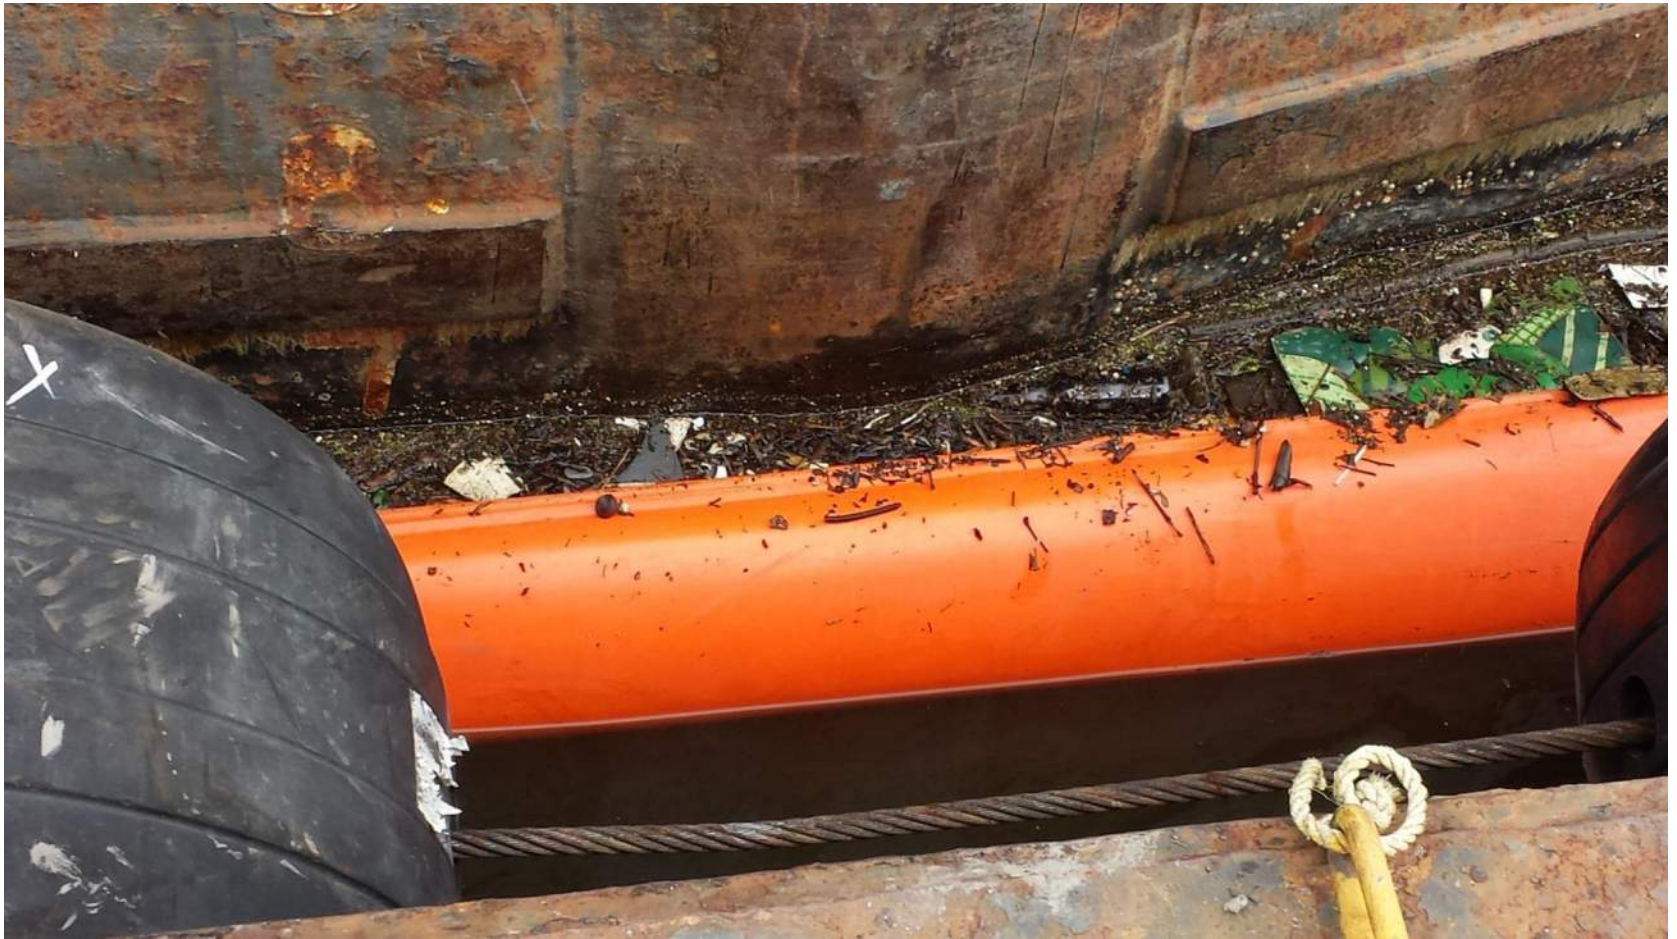
Silt Curtain acting as barrier between Trash/Debris and Dredge Area

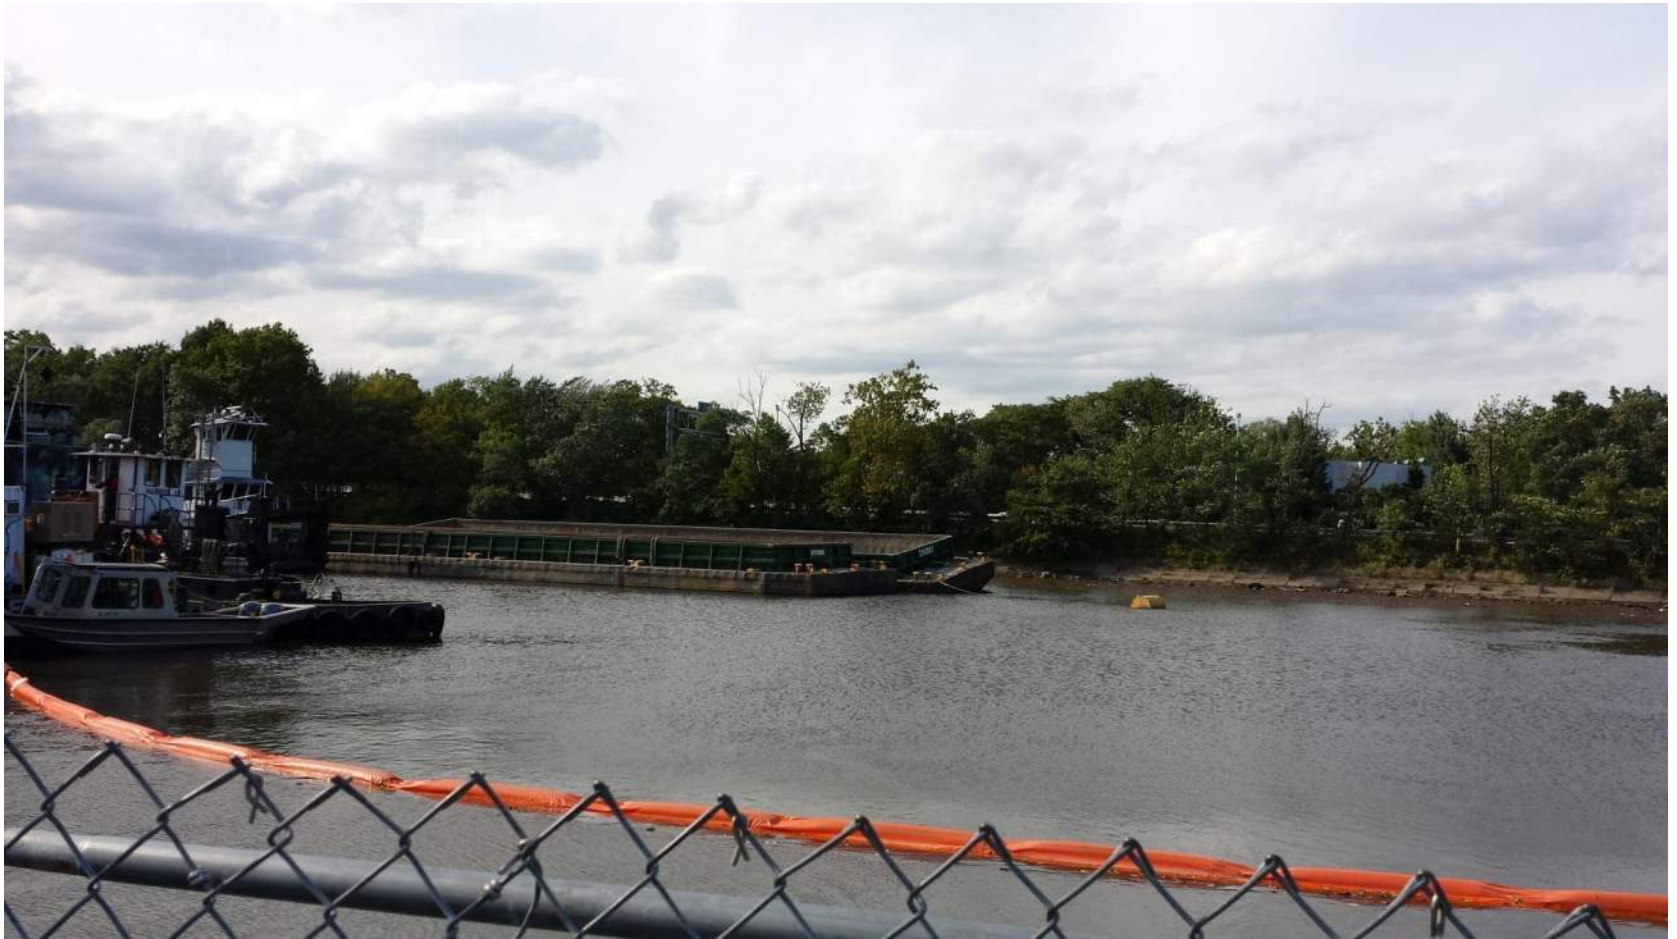
“Chubby” and “Stymie” moored for the evening.

Chubby is tilted not due to material inside, but is partially on the mudflat and being pulled down by anchors on each side.

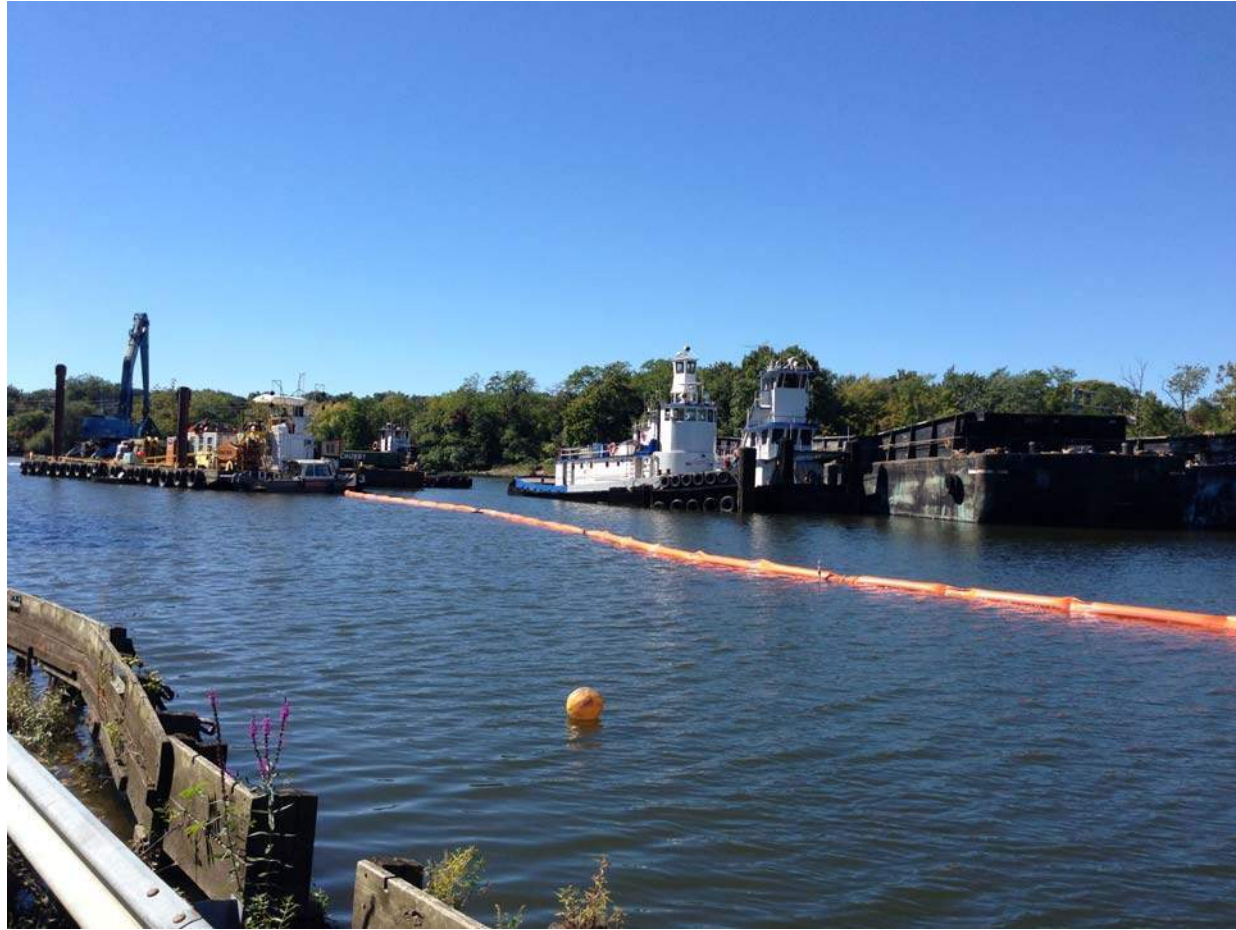
Sheen Near Boat Launch

A slight sheen on the river surface was observed around 0830 but was no longer visible by mid-morning. This has happened before, and was brought to the attention of the CPG representative. They are prepared to take further action (set up booms) if it ever were to become more severe.

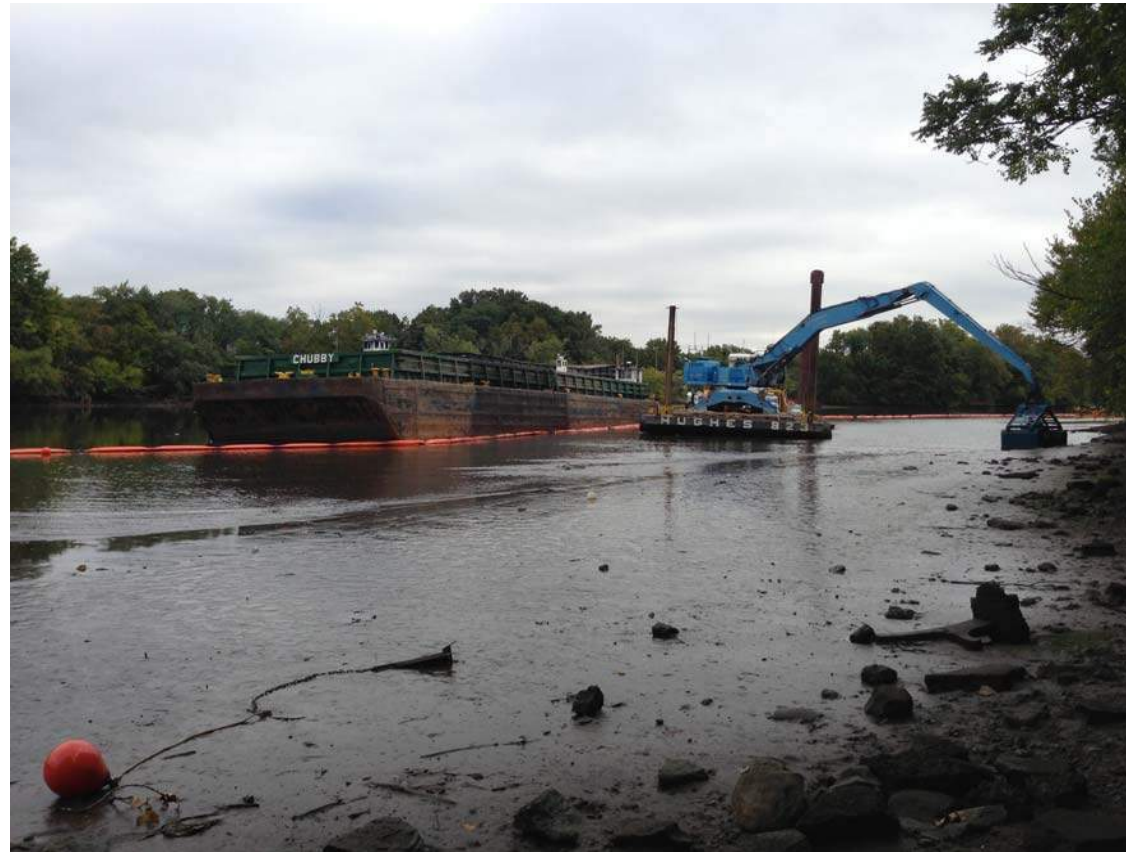
Low-Profile Scow Grounded at Low Tide

The low-profile “Chubby” scow was difficult to move at low-tide in the morning, but within a few hours the tide had come in substantially.

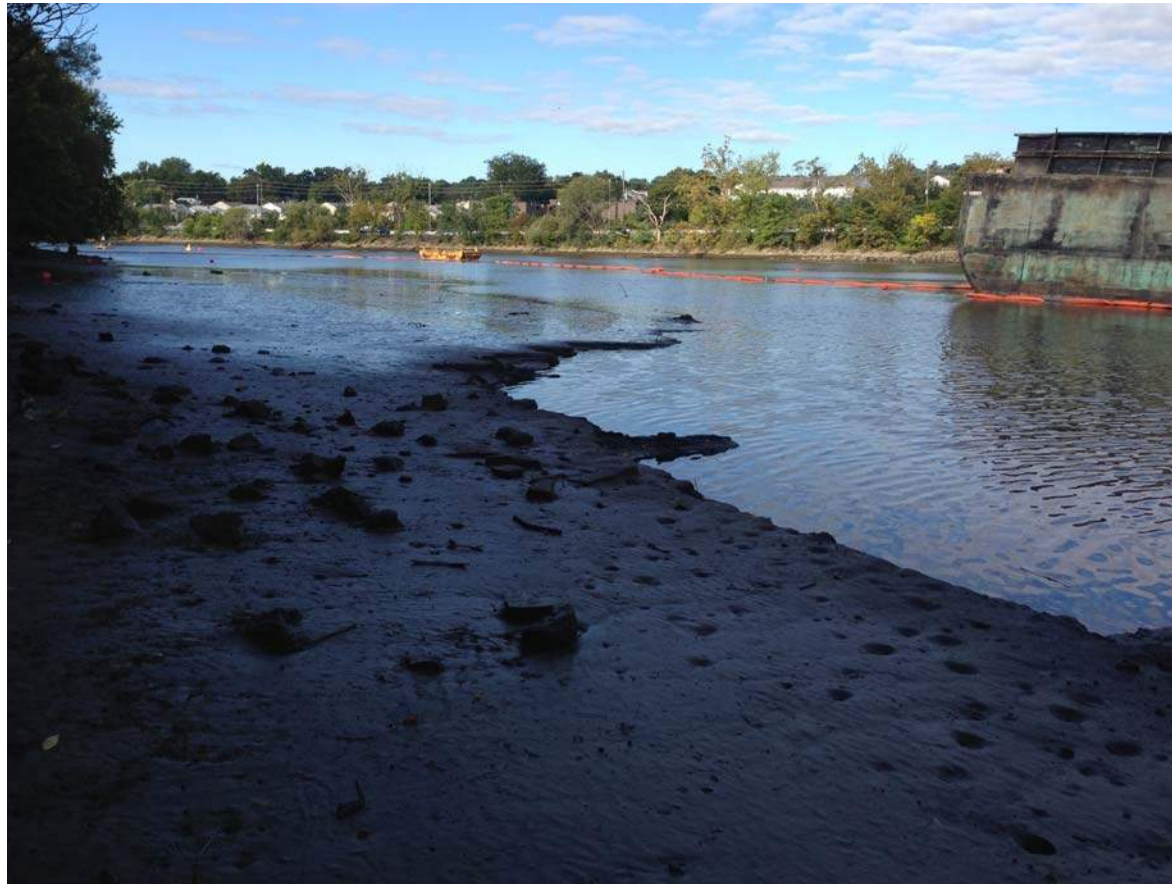
Edge of Dredging Progress

This photograph faces south and shows the approximate edge of the cut as of this morning (September 27, 2013). The orange buoys in the left of the picture represent the boundaries of the no-dredge zone, which is about 20 yards away.

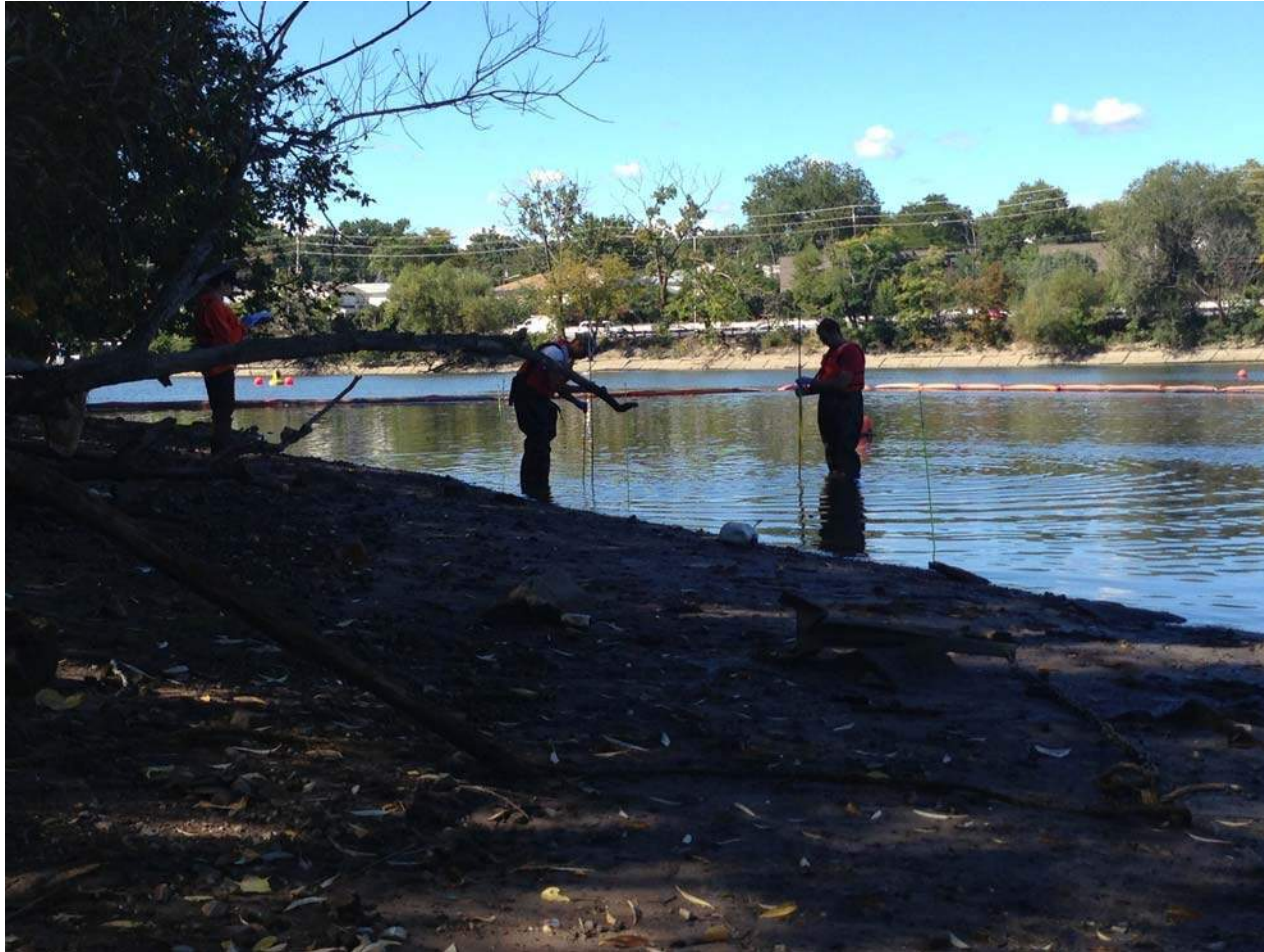
Sediment Probing in Cut 6T

A ½" diameter threaded steel rod was used to measure the depth of penetrable sediment. The depths varied largely and were greater away from the shore.

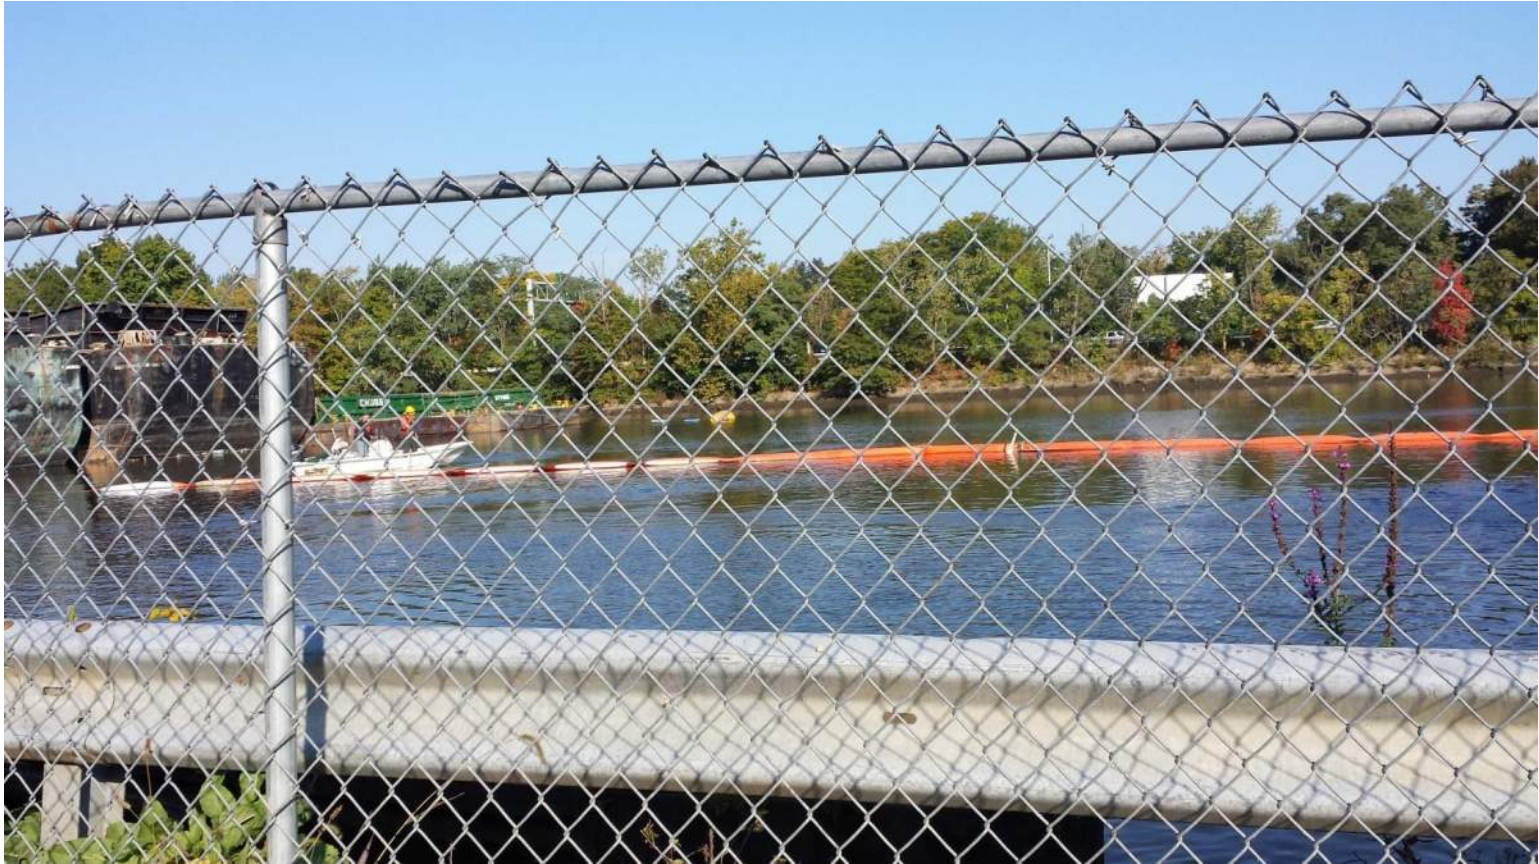
Early Morning Silt Curtain Issues

Silt Curtain was redeployed this morning, some issues with the inflatable pieces on the top ripping out of the curtain. The curtain was previously moved the night before to avoid navigation issues with having both high profile and low profile scows on site. Curtain was rearranged when high profile scows were back onsite.

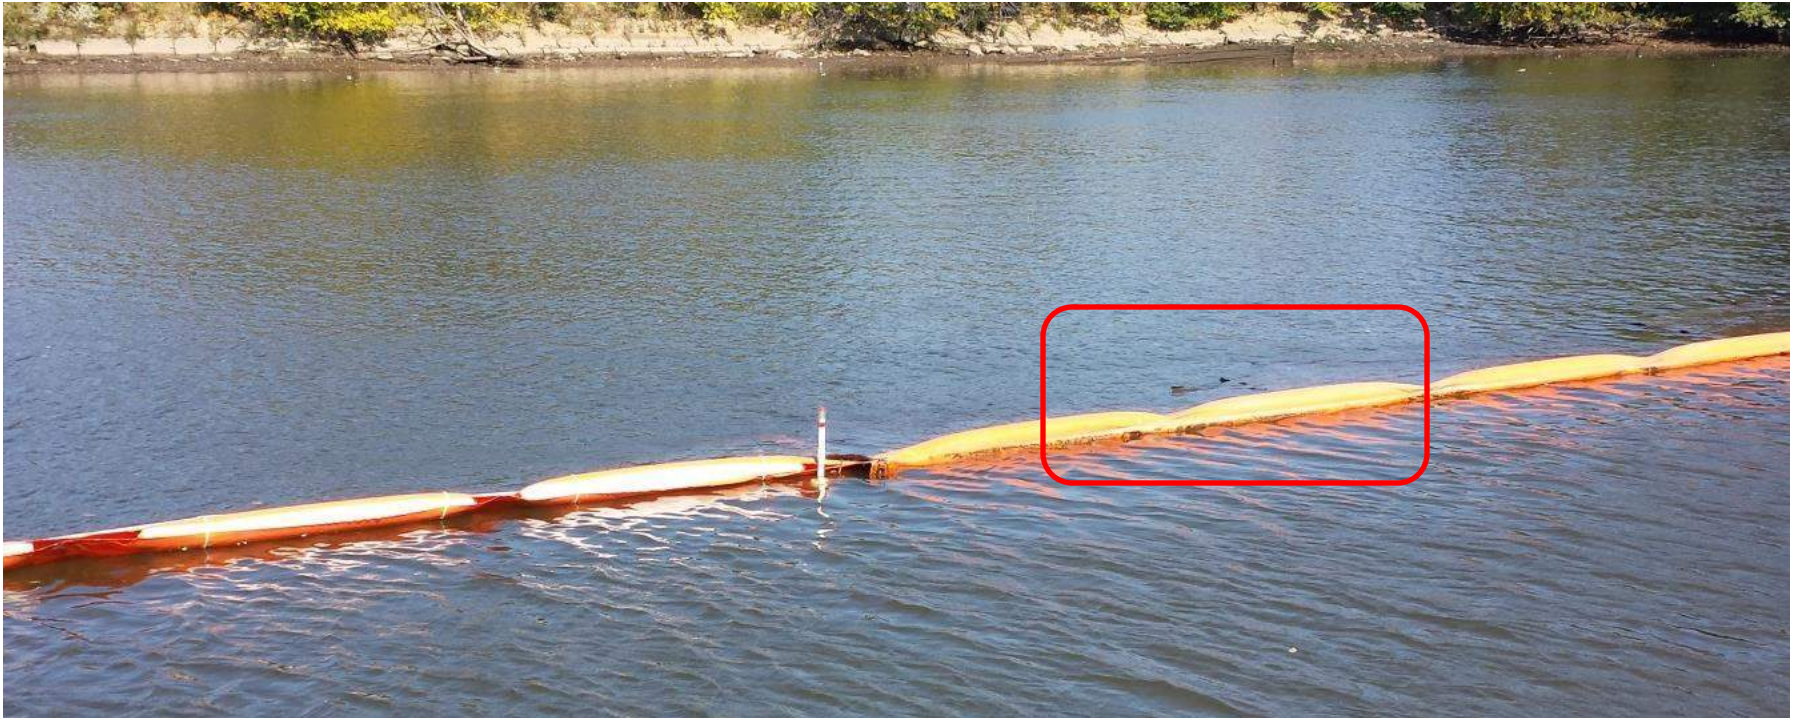
Silt Curtain Issues_1

Easy to see tearing along the “curtain” portion within the river.

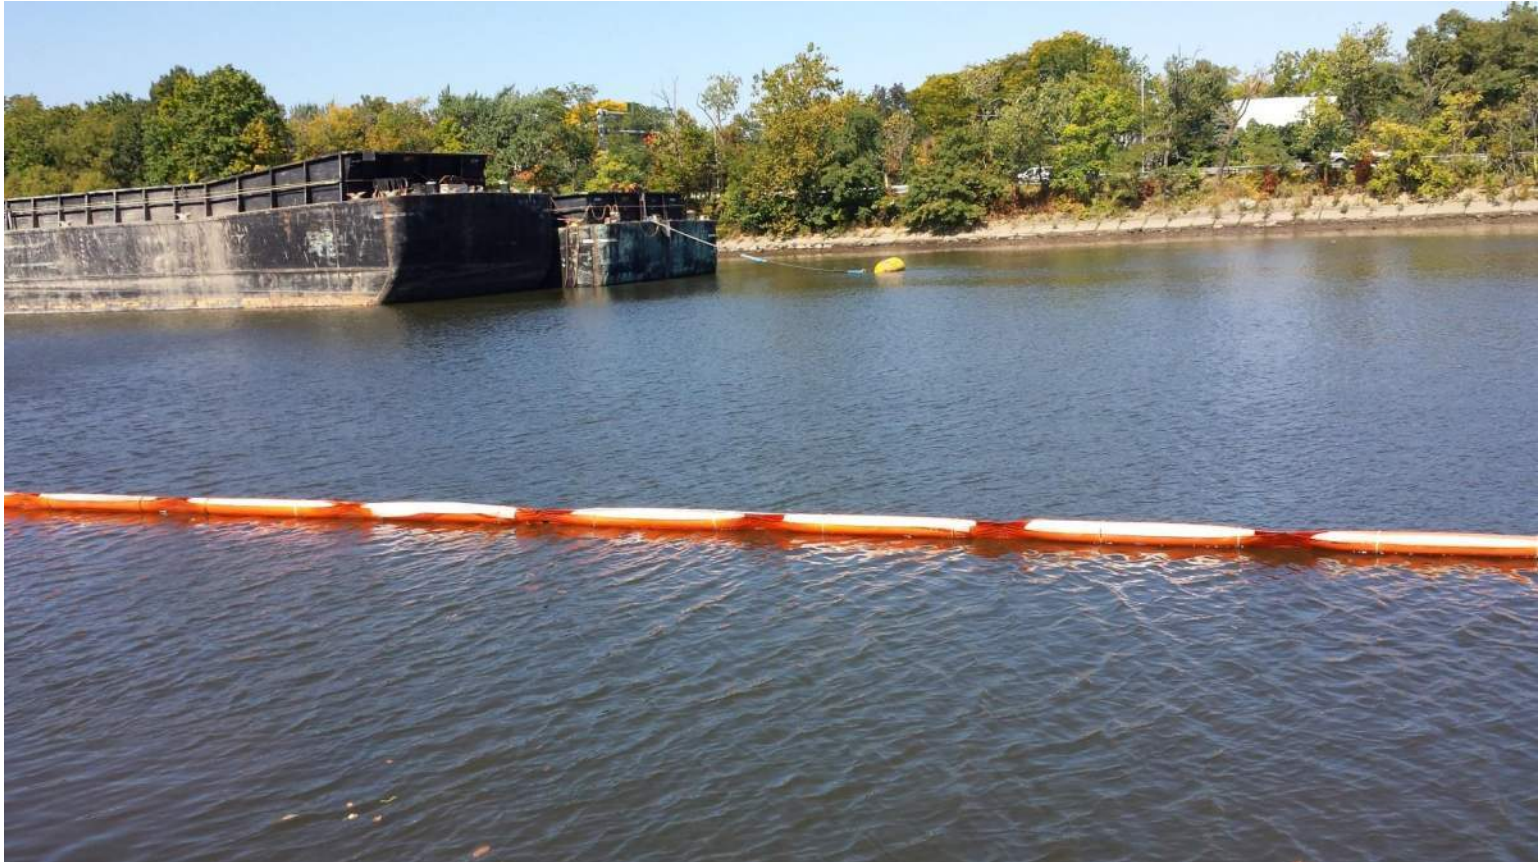
Silt Curtain Issues_2

The inflatable portion of the curtain had been roped shut to keep the pieces from floating away.

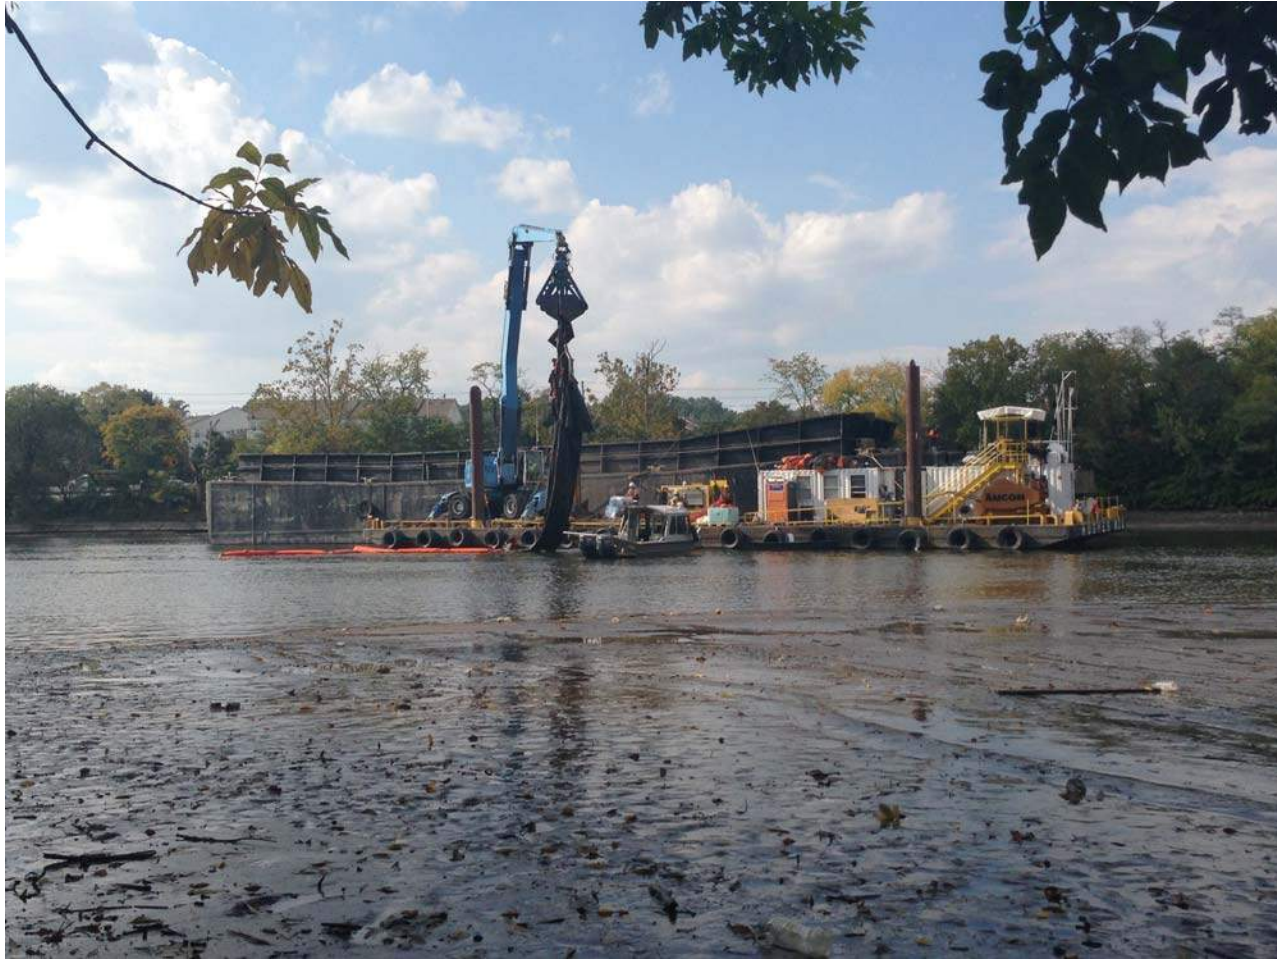
Silt Curtain Collection

The silt curtain deployed during dredging will not be reused; it was deposited into the high-profile scow pictured above and will be disposed of as waste.
